Medical Devices: The Therac-25 Story

System Safety and Computers

Nancy G. Leveson

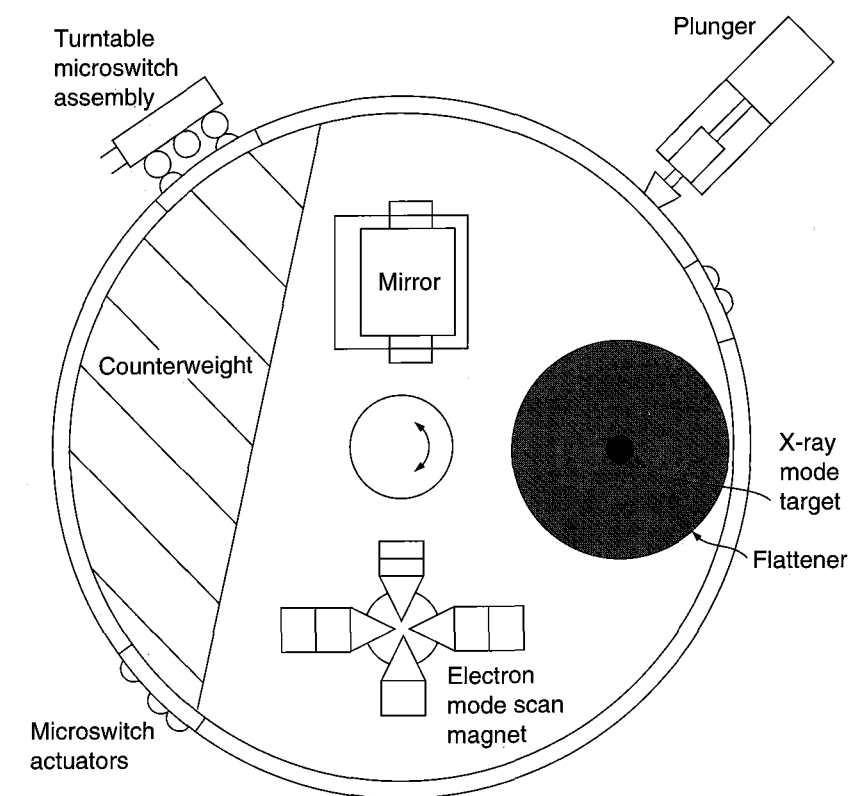
FIGURE A.1
Upper turntable assembly.

Turntable Positioning. The Therac-25 turntable design plays an important role in the accidents. The upper turntable (see Figure A.1) rotates accessory equipment into the beam path to produce two therapeutic modes: electron mode and photon mode. A third position (called the field light position) involves no beam at all, but rather is used to facilitate correct positioning of the patient. Because the accessories appropriate to each mode are physically attached to the turntable, proper operation of the Therac-25 is heavily dependent on the turntable position, which is monitored by three microswitches.

For X-ray (or photon) therapy, only one energy level is available: 25 MeV. Much greater electron-beam current is required for X-ray mode (some 100 times greater than that for electron therapy) [284] to produce comparable output. Such a high dose-rate capability is required because a “beam flattener” is used to produce a uniform treatment field. This flattener, which resembles an inverted ice cream cone, is a very efficient attenuator; thus, to get a reasonable treatment dose rate out of the flattener, a very high input dose rate is required. If the machine should produce a photon beam with the beam flattener not in position, a high output dose to the patient results. This is the basic hazard of dual-mode machines: If the turntable is in the wrong position, the beam flattener will not be in place.

(and for checking the turntable position) so that a target, flattening filter, and X-ray ion chamber are directly in the beam path. With the target in place, electron bombardment produces X-rays. The X-ray beam is shaped by the flattening filter and measured by the X-ray ion chamber.

No accelerator beam is expected in the third or field light turntable position. A stainless steel mirror is placed in the beam path and a light simulates the beam. This lets the operator see precisely where the beam will strike the patient and make necessary adjustments before treatment starts. There is no ion chamber in place at this turntable position, since no beam is expected.
