Medical Devices: The Therac-25*

Nancy Leveson
University of Washington

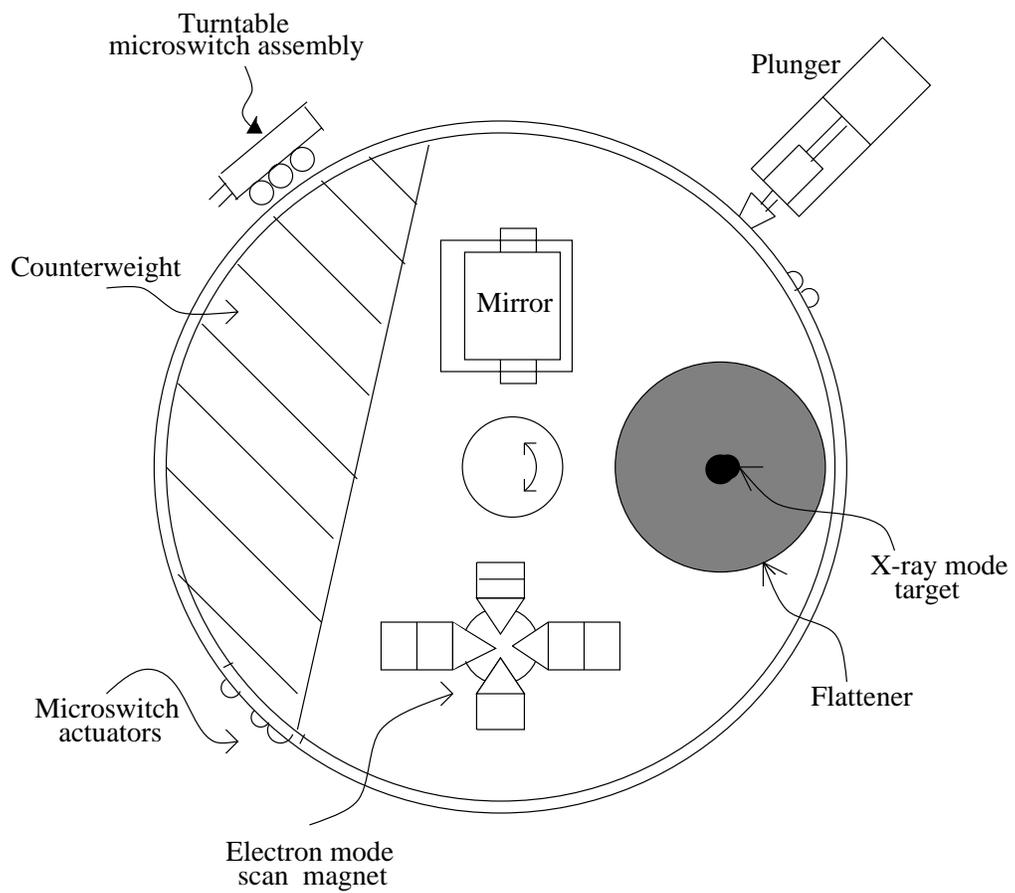
Turntable Positioning. The Therac-25 turntable design plays an important role in the accidents. The upper turntable (see Figure 1) rotates accessory equipment into the beam path to produce two therapeutic modes: electron mode and photon mode. A third position (called the field light position) involves no beam at all, but rather is used to facilitate correct positioning of the patient. Because the accessories appropriate to each mode

Figure 1: Upper turntable assembly.

are physically attached to the turntable, proper operation of the Therac-25 is heavily dependent on the turntable position, which is monitored by three microswitches.

AECL could not reproduce the malfunction that had occurred, but suspected a transient failure in the microswitch used to determine the turntable position. During the investigation of the accident, AECL hardwired the error conditions they assumed were necessary for the malfunction and, as a result, found some turntable positioning design weaknesses and potential mechanical problems.

The computer senses and controls turntable position by reading a 3-bit signal about the status of three microswitches in the turntable switch assembly. Essentially, AECL determined that a 1-bit error in the microswitch codes (which could be caused by a single open-circuit fault on the switch lines) could produce an ambiguous position message to the computer. The problem was exacerbated by the design of the mechanism that extends a plunger to lock the turntable when it is in one of the three cardinal positions: The plunger could be extended when the turntable was way out of position, thus giving a second false position indication. AECL devised a method to indicate turntable position that tolerated a 1-bit error so that the code would still unambiguously reveal correct position with any one microswitch failure.

The modifications specified in the Symonds report included redesigning the microswitch and changing the way the computer handled malfunction conditions. In particular, treatment was to be terminated in the event of a dose-rate malfunction, giving a treatment “suspend.” This change would have removed the option to proceed simply by pressing the \textcircled{P} key. The report also made recommendations regarding collimator test procedures and message and command formats. A November 8, 1985 letter, signed by the director of the Canadian RPB, asked that AECL make changes to the Therac-25 based on the Symond’s report “to be in compliance with the RED act.”

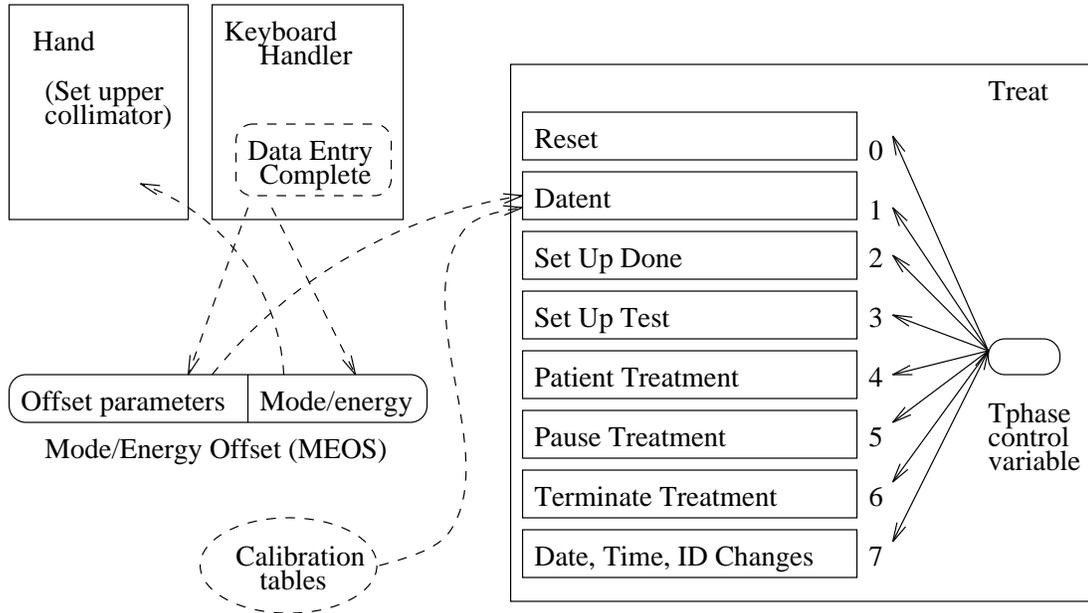
Figure 3: Tasks and subroutines in the code blamed for the Tyler accidents.

The treatment monitor task (Treat) controls the various phases of treatment by executing its eight subroutines. The treatment phase indicator variable (Tphase) is used to determine which subroutine should be executed (Figure 3). Following the execution of a particular subroutine, Treat reschedules itself.

But this is not the only problem. Upon exit from the Magnet subroutine, the data entry subroutine (Datent) checks the Data Entry Complete variable. If it indicates that data entry is complete, Datent sets Tphase to 3 and Datent is not entered again. If it is not set, Datent leaves Tphase unchanged, which means it will eventually be rescheduled. But the Data Entry Complete variable only indicates that the cursor has been down to the command line, not that it is still there. A potential race condition is set up. To fix this, AECL introduced another shared variable controlled by the keyboard handler task that indicates the cursor is not positioned on the command line. If this variable is set, then prescription entry is still in progress and the value of Tphase is left unchanged.

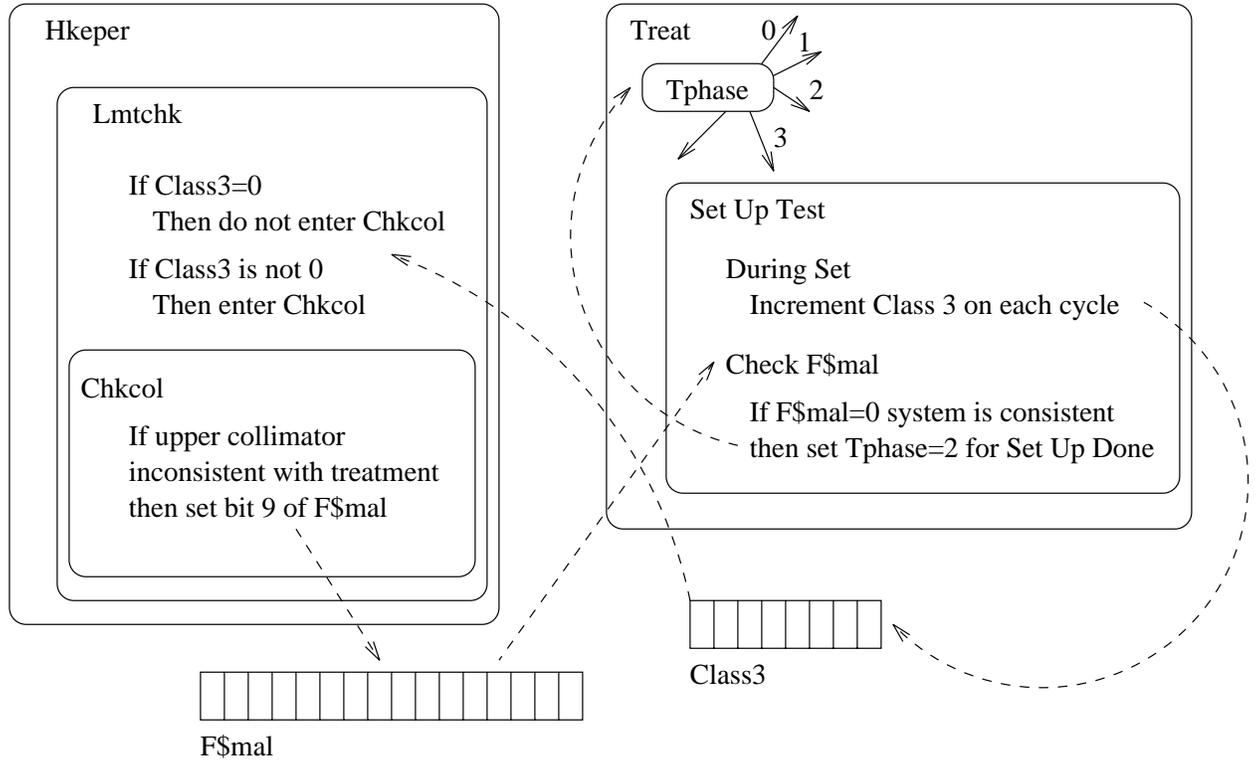
The second Yakima accident was again attributed to a type of race condition in the software — this one allowed the device to be activated in an error setting (a “failure” of a software interlock). The Tyler accidents were related to problems in the data-entry routines that allowed the code to proceed to Set Up Test before the full prescription had been entered and acted upon. The Yakima accident involved problems encountered later in the logic after the treatment monitor Treat reaches Set Up Test.

Figure 4: The Yakima software flaw.

The overexposure occurred when the operator hit the “set” button at the precise moment that Class3 rolled over to zero. Thus, Chkcol was not executed and F\$mal was not set to indicate that the upper collimator was still in the field-light position. The software turned on the full 25 MeV without the target in place and without scanning. A highly concentrated electron beam resulted, which was scattered and deflected by the stainless

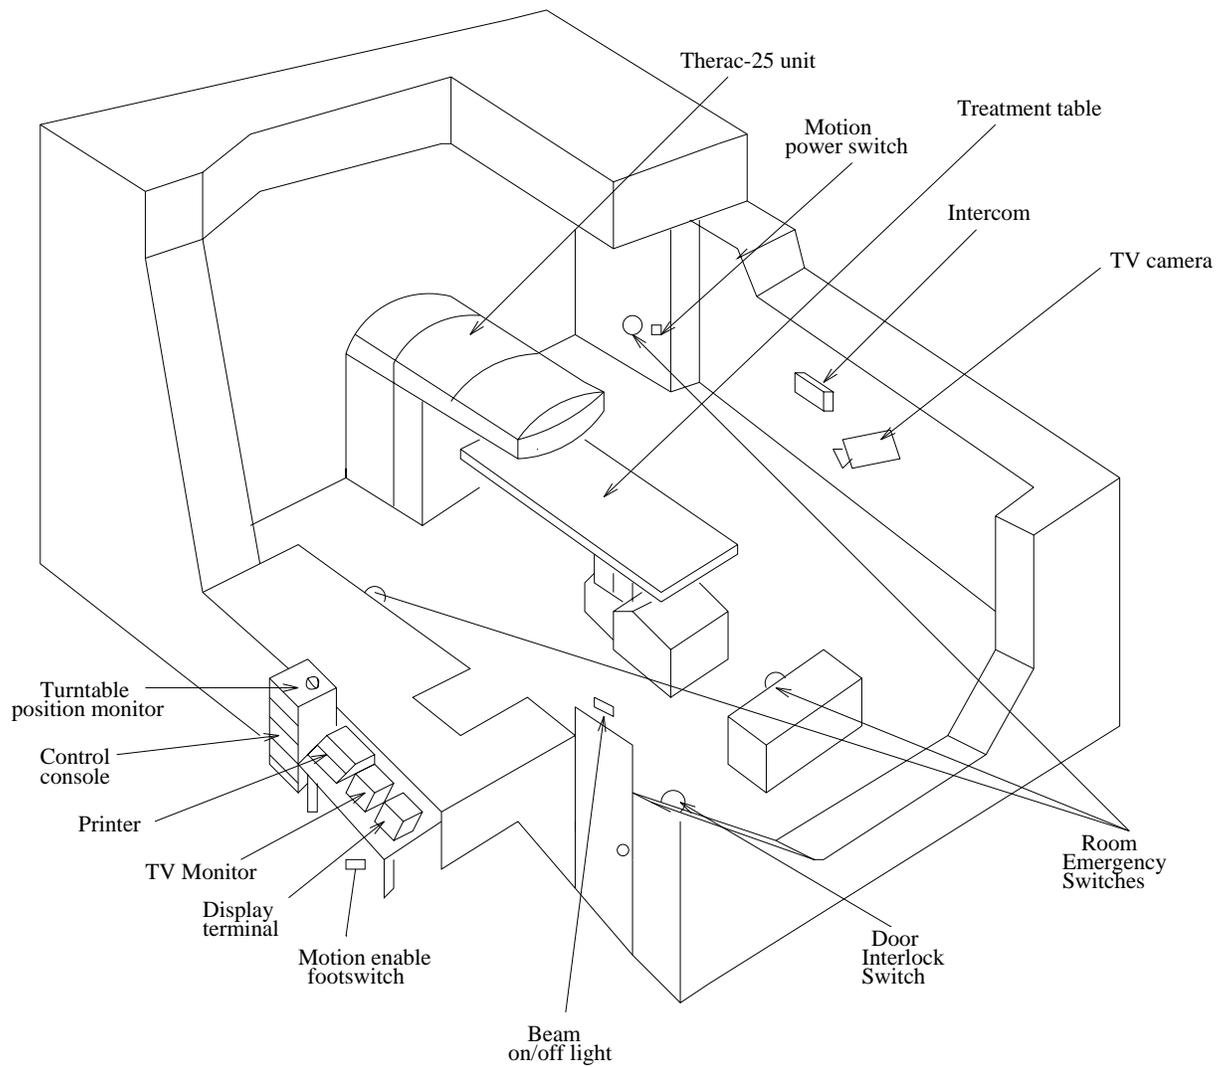
Figure 5 shows a typical Therac-25 installation after the CAP changes were made.

Figure 5: A typical Therac-25 facility after the final CAP.

- The known software problems associated with the Tyler and Yakima accidents will be fixed.
- The manuals will be fixed to reflect the changes.
